Withiel HGV Route Feasibility Study

Design Feasibility Report

Infra22-085-CSL-GEN-SW994653-RP-CH-0001

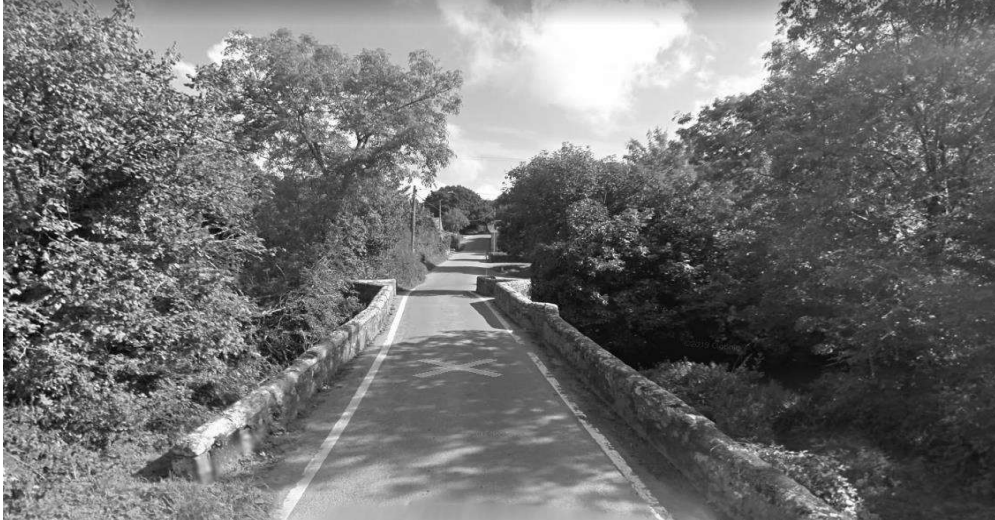
Figure 1.3 –Scheduled monument Ruthernbridge (Google Streetview , 2010)

Ruthernbridge is a small rural village located within the parish of Withiel. It is centred around an early 15th-century bridge (Figure 1.3). Historic England has it listed as a scheduled monument. The bridge has a width of 2.36m at its central point. The village has a main C class road, that runs from west to east through the village.

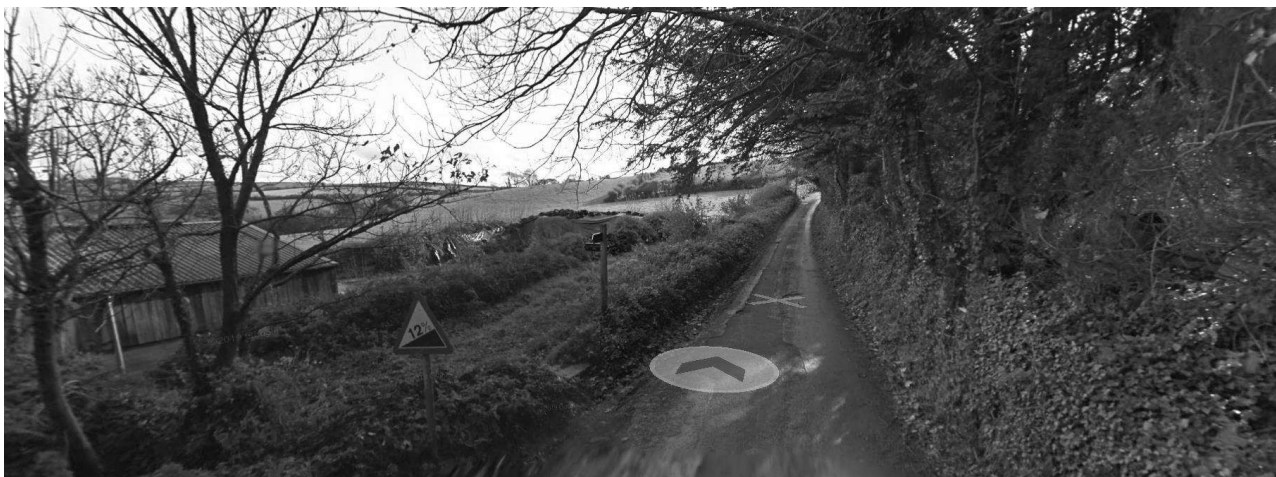
Figure 1.4 – South Exit to village travelling southbound (Google Streetview , 2010)

Withiel is a rural village located to the southwest of Ruthernbridge, linked by narrow lanes. There is a 12% incline on the southern side of the of the village when leaving the village and travelling south (figure 1.4).

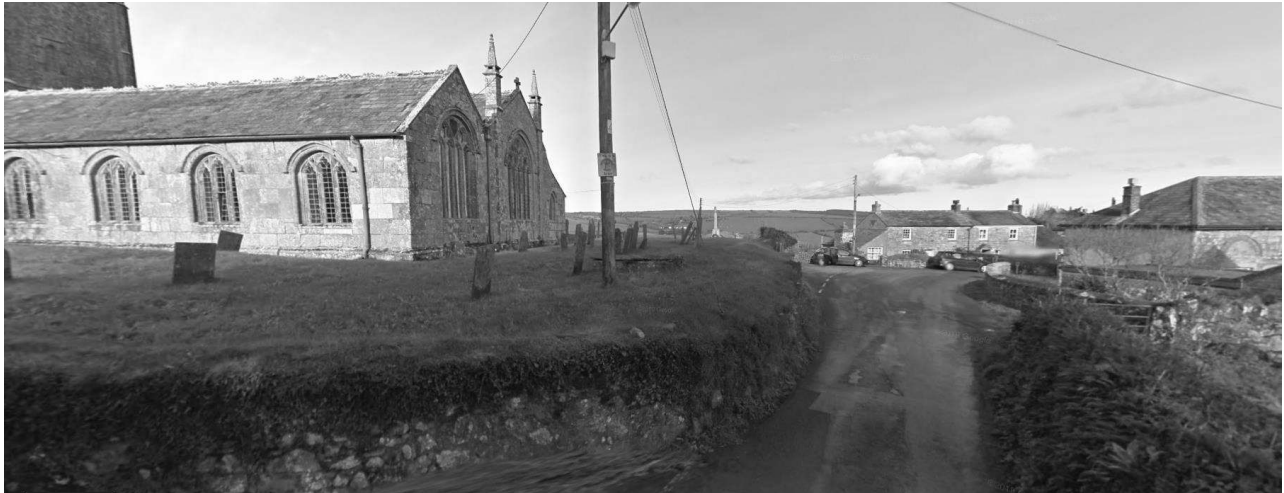
Figure 1.5 – Withiel Church and Grade 2 listed wall. South entrance to village travelling northbound (Google Streetview, 2010)

- 1.2.5 There is a valley located to the north of the village. As a result of the topography, both northbound and southbound vehicles travelling through the village must negotiate steep gradients. Within Withiel village there is a Grade 1 listed church, attached to a Grade 2 listed church wall (Figure 1.5) , the road width at this location is 2.9m. There is damage to the existing Grade 2 listed Church wall. This damage has most likely occurred as a result of the wall being struck by a large vehicle.

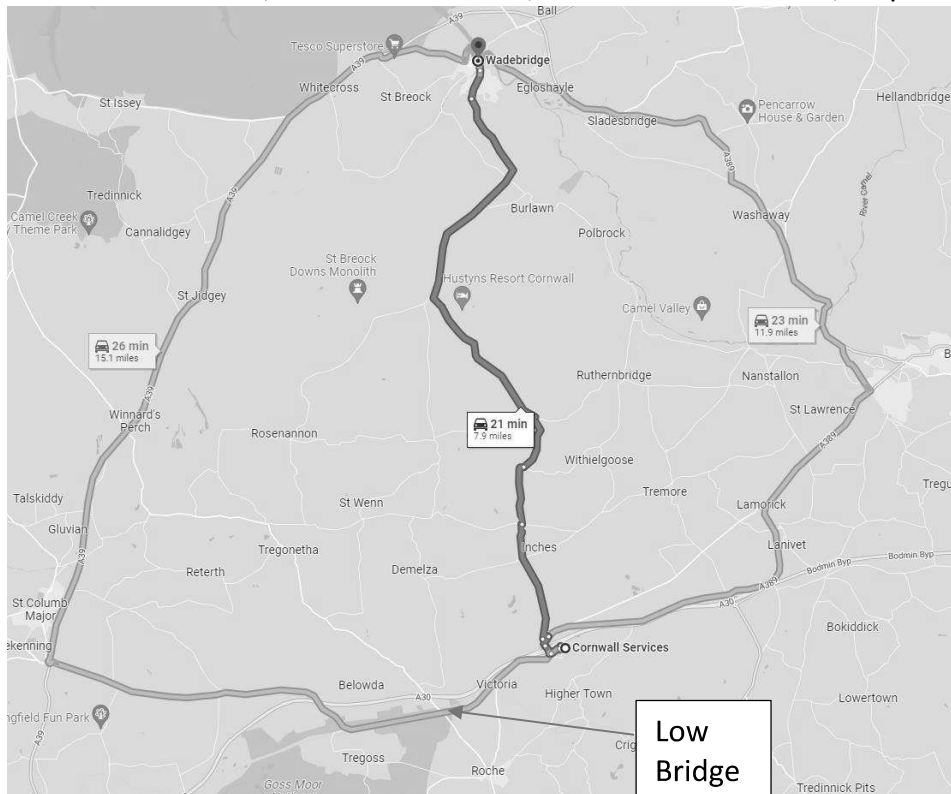
Figure 2.4 – SAT-NAV route and alternate options. (Google Maps, 2022)

- 2.3.7 The route advised by Google Maps, between Cornwall Services and Wadebridge, (Figure 2.4) takes 21 minutes. This does not account for the terrain and the suitability of the roads, through and around Withiel. The alternative routes of the A39 or A389 routes, as indicated below, take 26 or 23 minutes, respectively.

- 2.3.8 The route eastbound, as shown in figure 2.4, that uses the A389 via Bodmin is suitable for HGV traffic. The route westbound, as shown in figure 2.4, is not suitable as it has height restrictions in the form of a low bridge. The alternate westbound route avoiding the bridge and using the A30 then A39 northbound is longer.
- 2.3.9 An Annual Average Daily Traffic (AADT) count was recorded in 2019. This states that 320 vehicles per day (two way) use the road, through zone 1 Ruthernbridge.

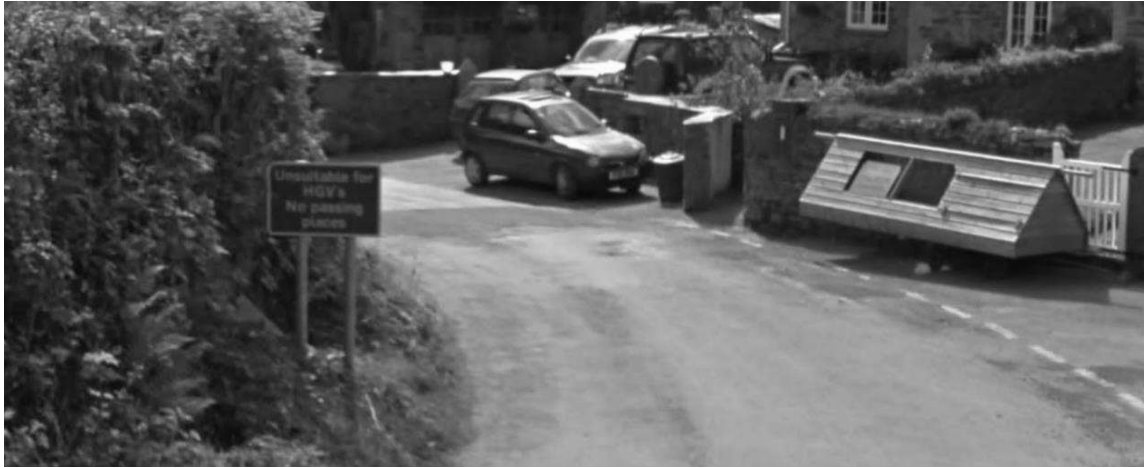
Figure 2.5 unsuitable for HGV no passing places advisory sign (Google Streetview , 2010)

- 2.4.1 **Withiel:** Motorists travelling through Withiel are made aware that the roads are unsuitable for HGVs, with no designated passing places, by the use of signs. These signs are located as shown above in figures 2.1 and 2.2.

- 2.4.2 This sign in figure 2.5 is located on the junction of the 2019 traffic count highlighted shown as point A in figure 2.3. The Traffic count data 2.3.3, shows that 2 HGVs travelled into/through Withiel and past the existing sign.
- 2.4.3 The text, location and height of the sign may all contribute to its effectiveness.
- 2.4.4 The position of the sign could be improved. South bound traffic turning in to the junction north of the sign (figure 2.6), won't see the sign until it is too late to turn around. Following this sign there are very limited opportunities for HGVs to perform a U turn manoeuvre.

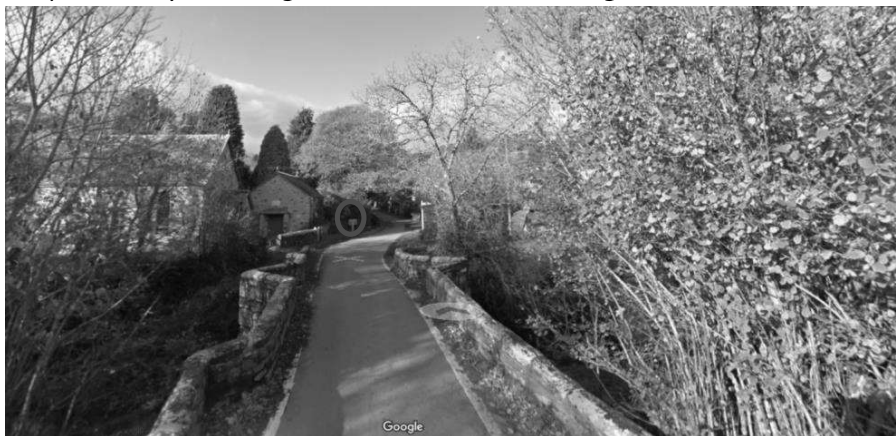
Figure 2.8 Ruthernbridge looking westbound to blue sign (highlighted in red) (Google Streetview , 2010)

- 2.4.9 **Ruthernbridge:** The village has an unsuitable for HGVs sign located on the west side of the river Ruthern and across the bridge see figure 2.8. The sign advises road users travelling westbound across Ruthernbridge that the road to the west towards Withiel is unsuitable for HGVs no passing places. Its location could be improved by warning drivers before the bridge.

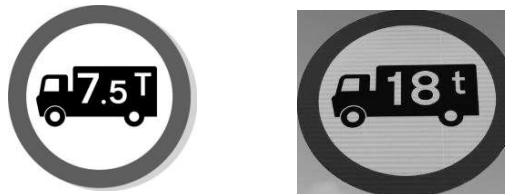
4.1 Option 1- TRO and weight prohibition signing

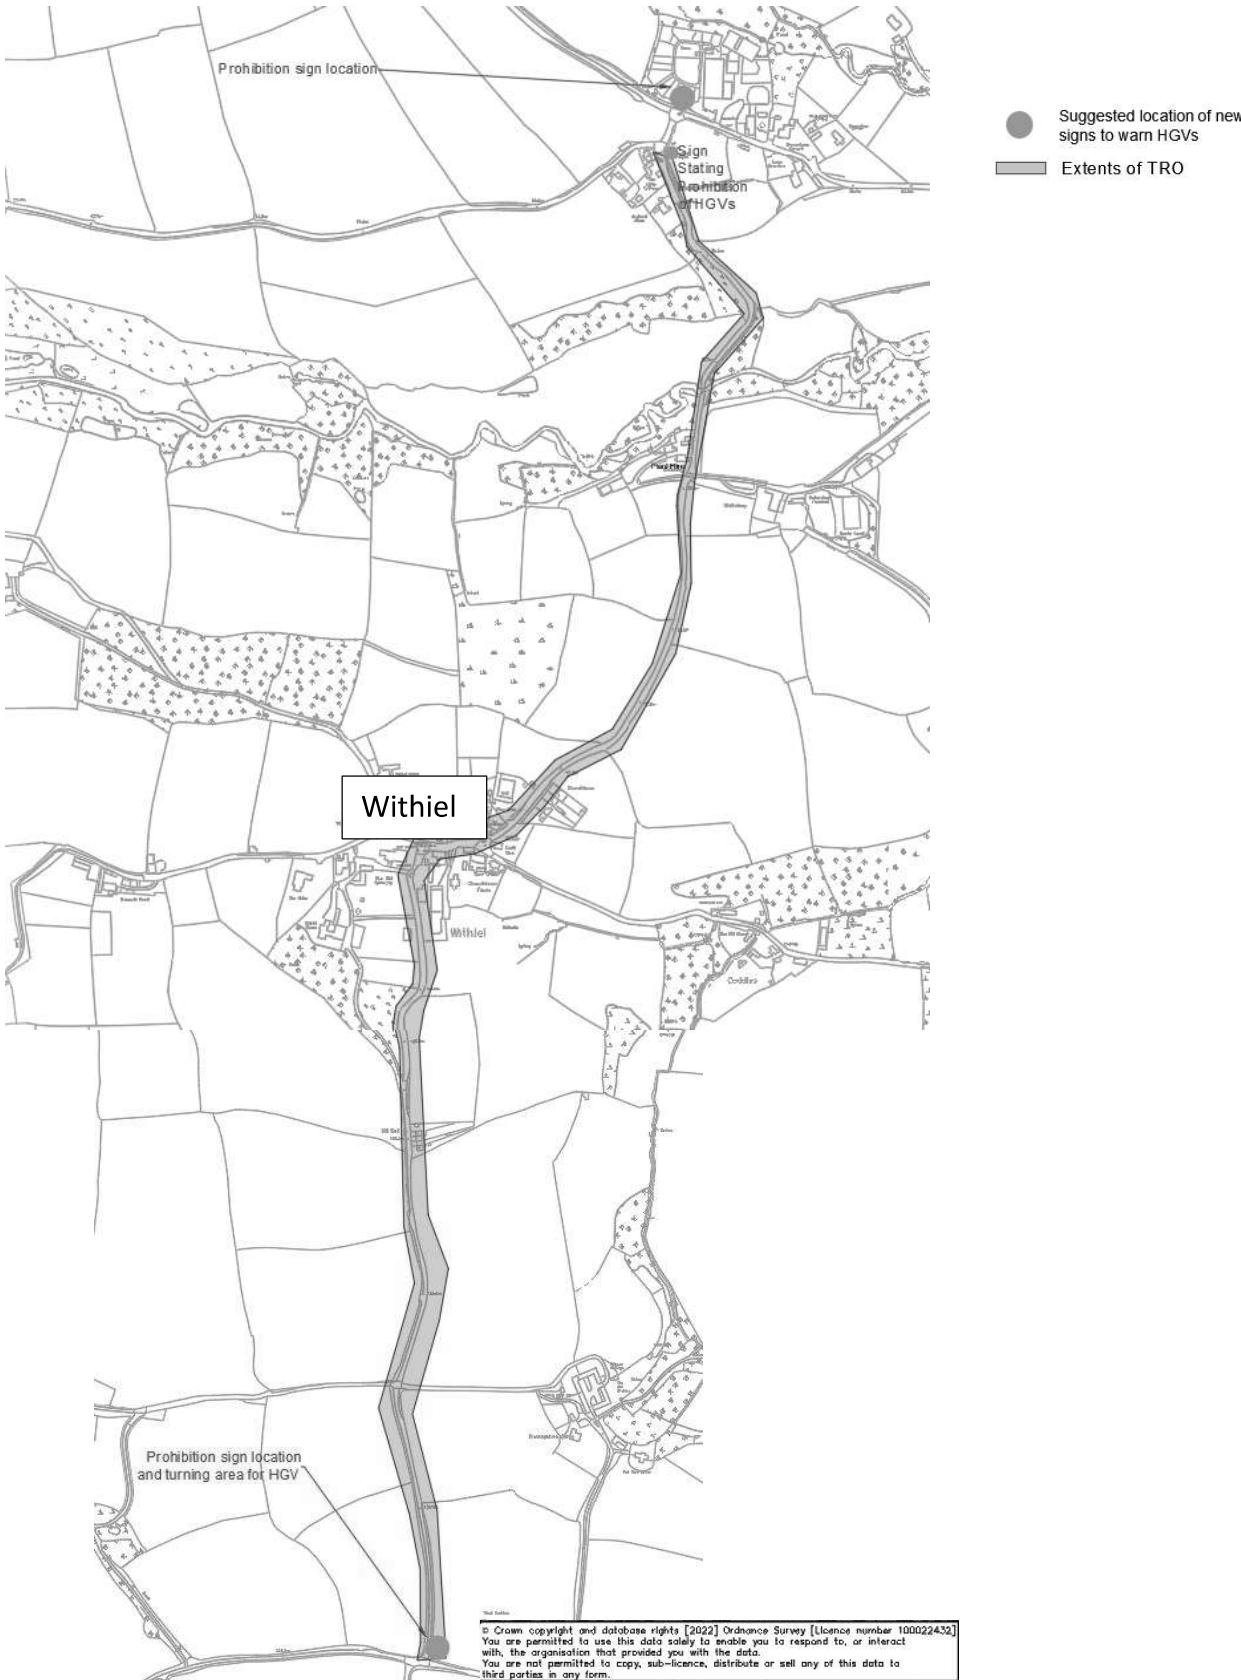
Figure 4.1 suggested signing and potential turning point locations

4.1.2 It is recommended that this new traffic engineering proposal is delivered by the process of a 3-week consultation followed by the permanent implementation of a Traffic Regulation Order (TRO) with the addition of improved directional signage as shown by the green marks in Figure 4.1, 4.2 and 4.3.

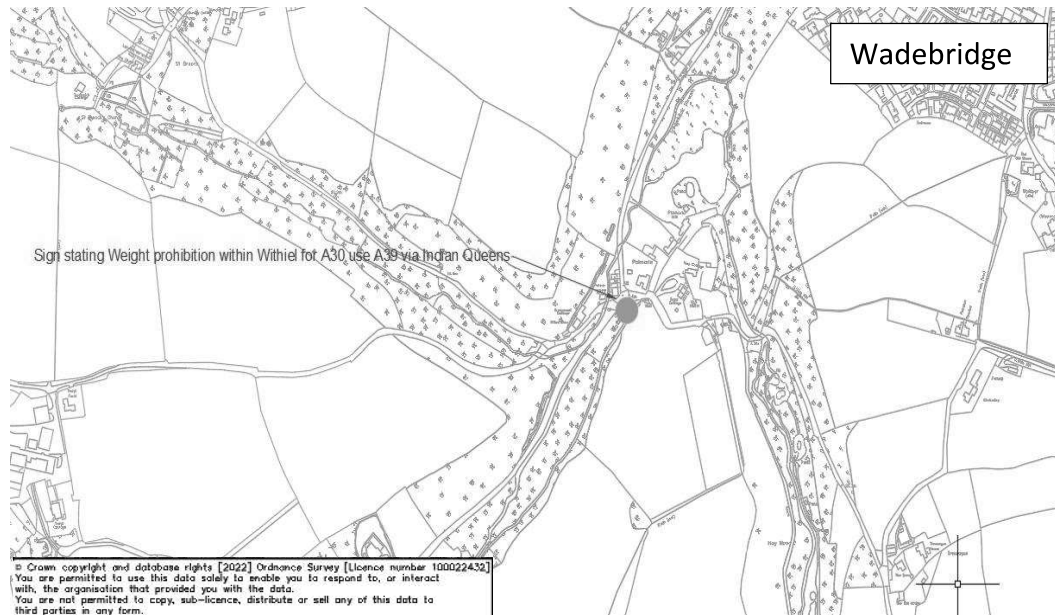
Figure 4.3 signing warning HGV drivers of weight restriction within Withiel

- 4.1.8 HGVs travelling southbound to Victoria services or on to the A30 will be warned by signage at Polmorla outside of Wadebridge (figure 4.3) of the weight limit in Withiel. This will advise them to use the more appropriate route of the A39 located to the west and then travel south via Indian Queens, using the diversion shown in (figure 4.5, blue route). Polmorla was chosen as it was the best place to redirect traffic onto the A39. Other possible areas were reviewed however they all were unsuitable for HGVs this was shown with both signage and general characteristics of the roads.

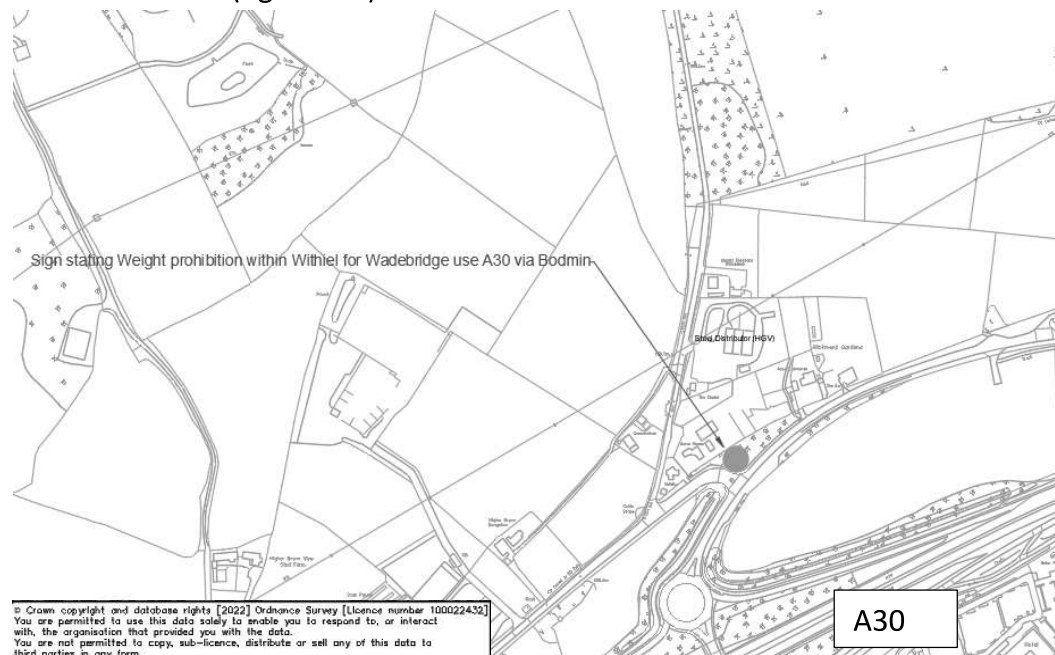
Figure 4.4 signing warning HGV drivers of the weight restriction within Withiel

- 4.1.9 HGVs travelling northbound to Wadebridge will be warned of the weight limit in Withiel and advised to return to the A389 and travel eastbound via Bodmin towards Wadebridge. This is a result of the existing height restriction associated with the iron bridge on the A39 (figure 4.5, red route). Signing location will be close to the A30 (figure 4.4)

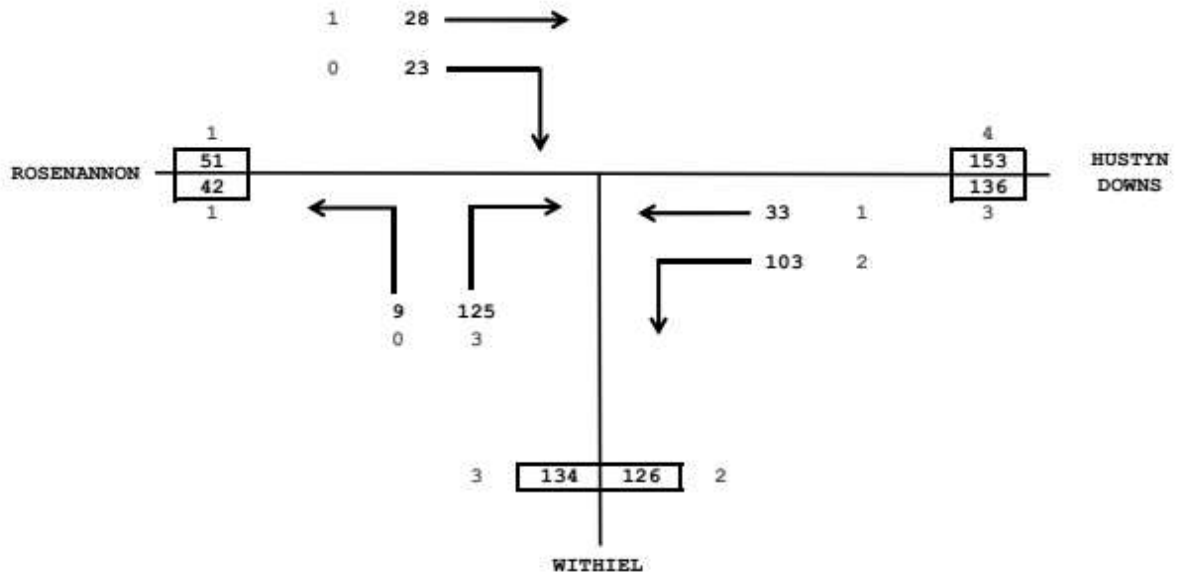
12 Hour Flows - 07:00 to 19:00

- 5123 All motor Vehicles (excluding Motor Cycles)
- 34 Heavy Commercial Vehicles (HGVs and Buses/Coaches)
